Attachment A: Digital Images

BOE Building Break Rooms 704, 143, Area 2304, and 23WRR Clearances
Sacramento, CA

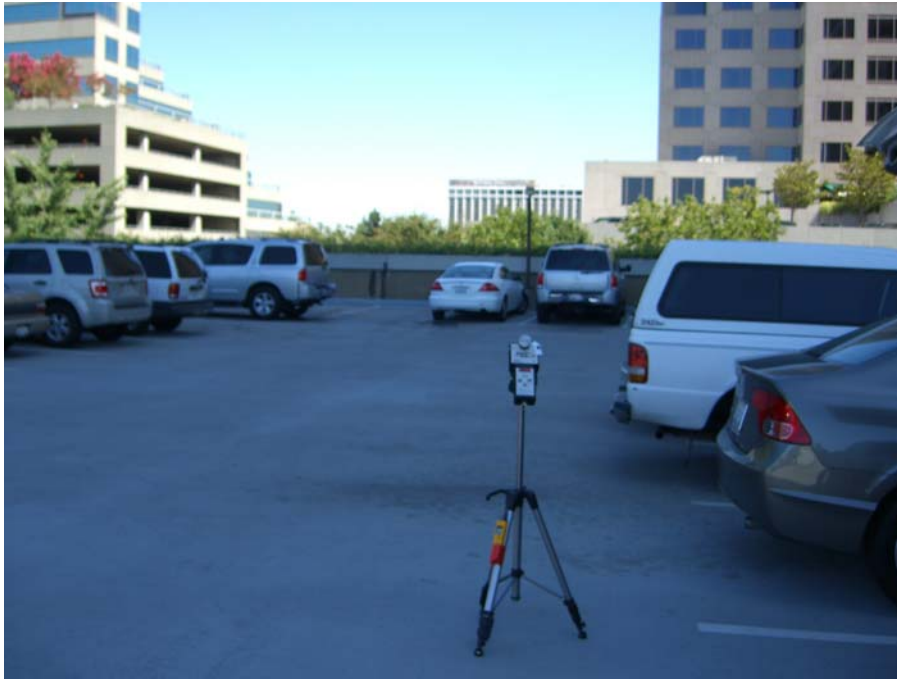
- 1) Image of ambient air sampling location at rooftop of garage structure adjacent to the BOE building (Subject Building) located at 450 N Street, Sacramento.

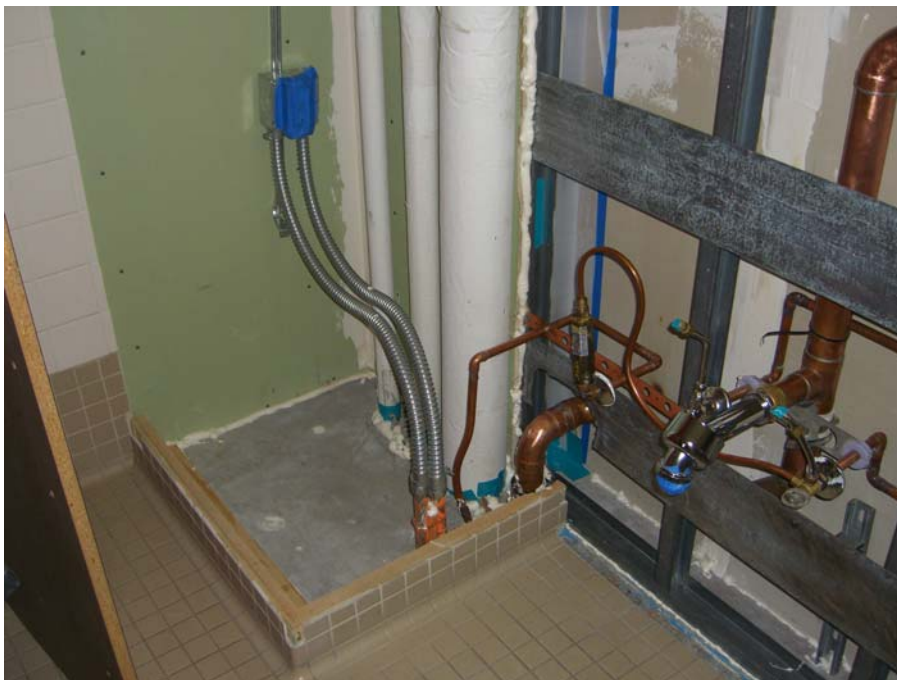
- 2) Image of interior of left side of women's restroom located on 23rd floor of subject building at time of assessment.

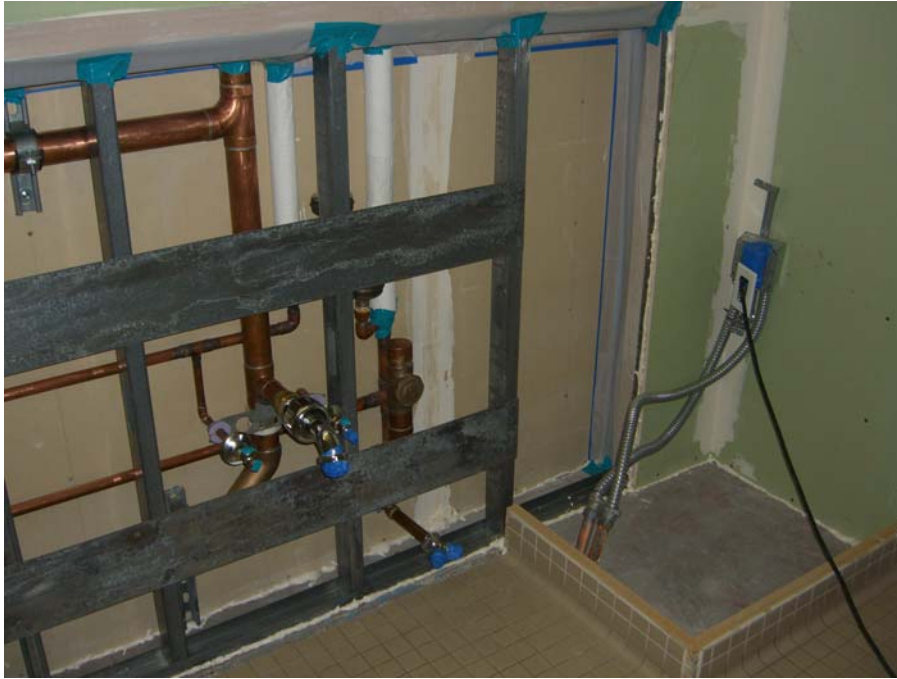
- 3) Image of right side of women's restroom located on 23rd floor of subject building at time of assessment.

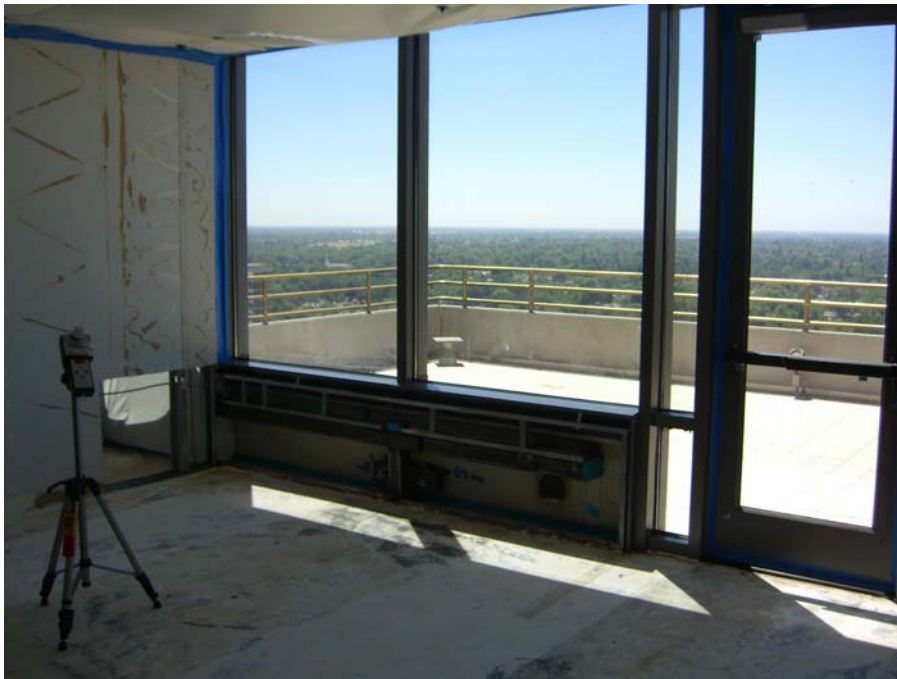
- 4) Image of interior of 2304 containment area ("Edwards Corridor") indicating extent of wall/floor removal and conditions at time of assessment.

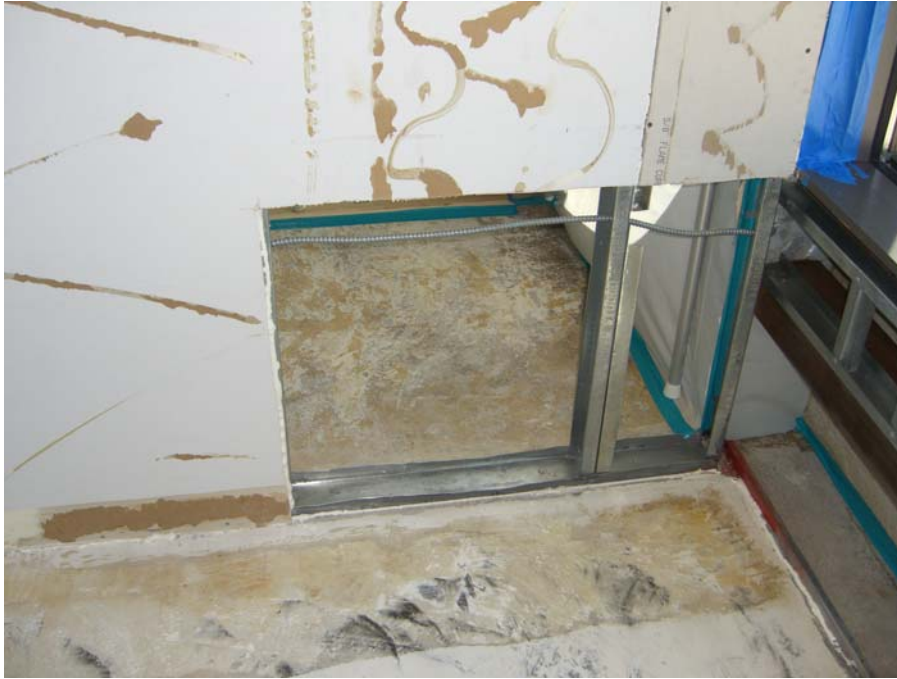
- 5) Image within containment 2304 indicating interior wall section removal at perimeter wall as removed during mitigative effort.

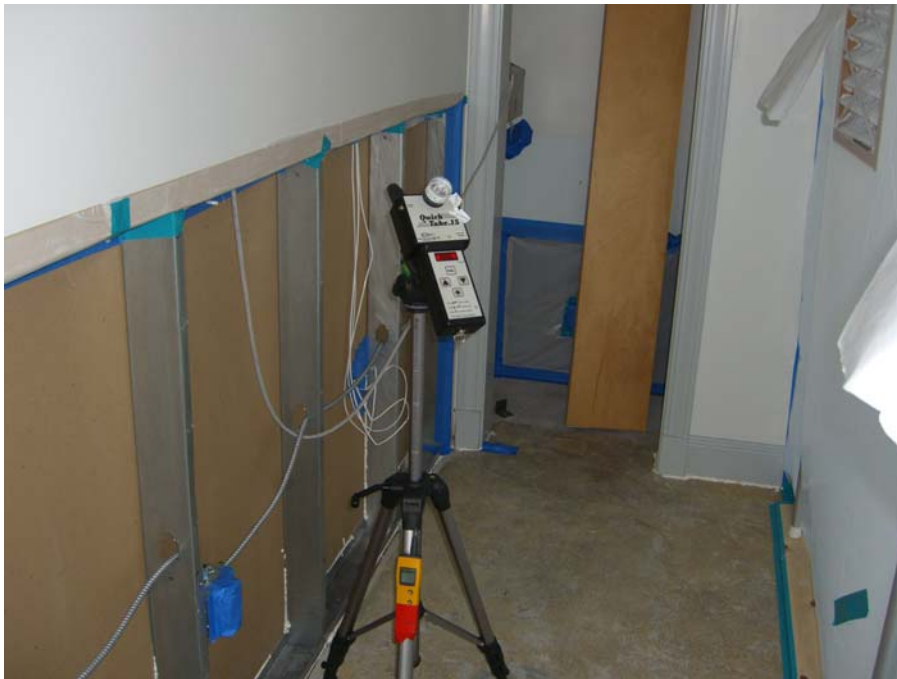
- 6) Image of air sampling activity performed within room 2339 within same containment and adjacent to Edwards Corridor at time of assessment.

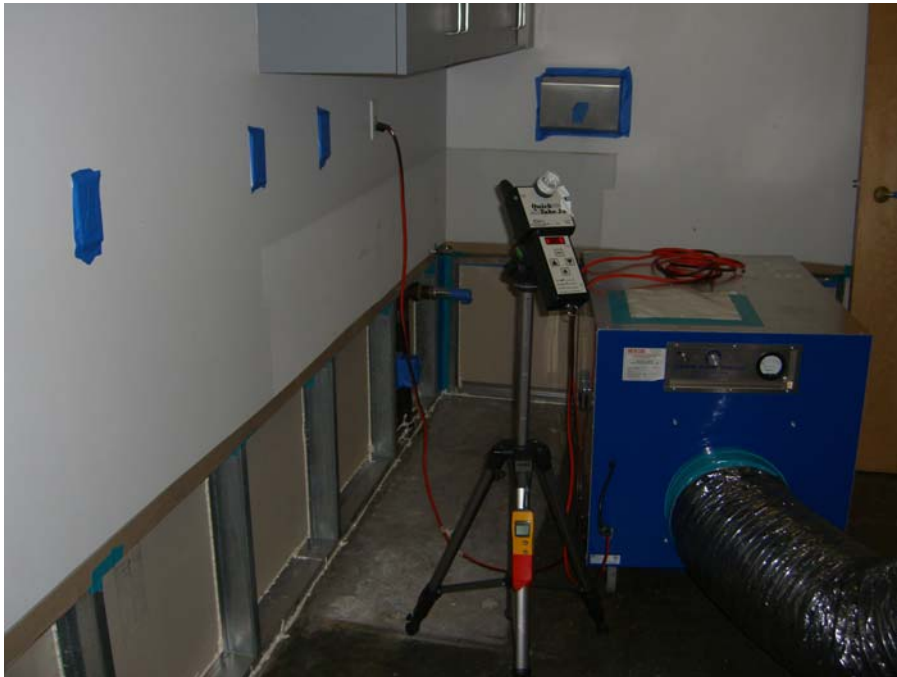
- 7) Image of air sampling performed within interior of break room containment 704 indicating extent of wallboard removal.

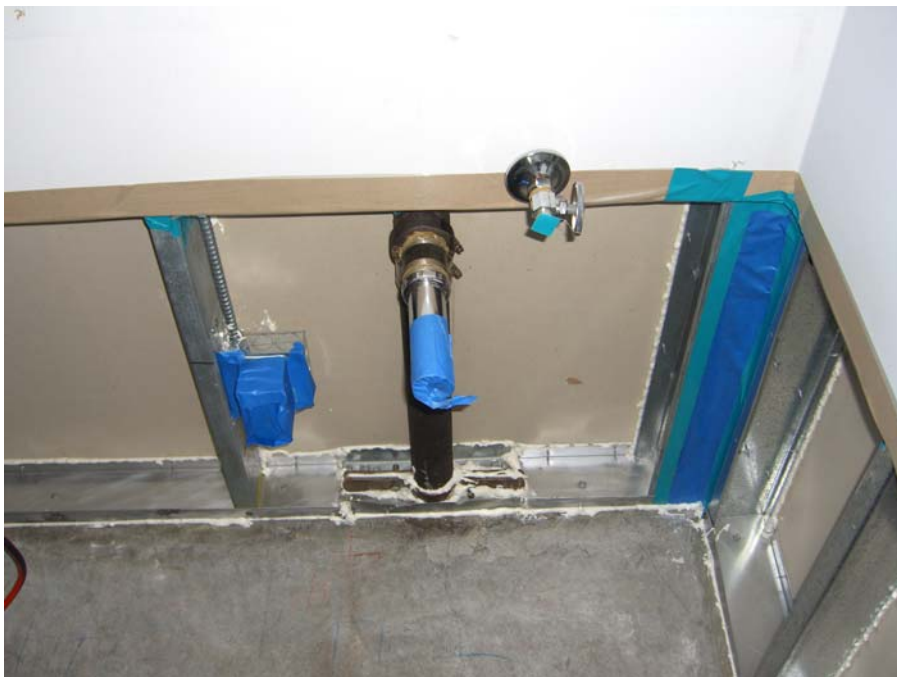
- 8) Close-up image of plumbing and wall cavity areas at former location of break room cabinetry within 704 at time of post mitigation assessment.

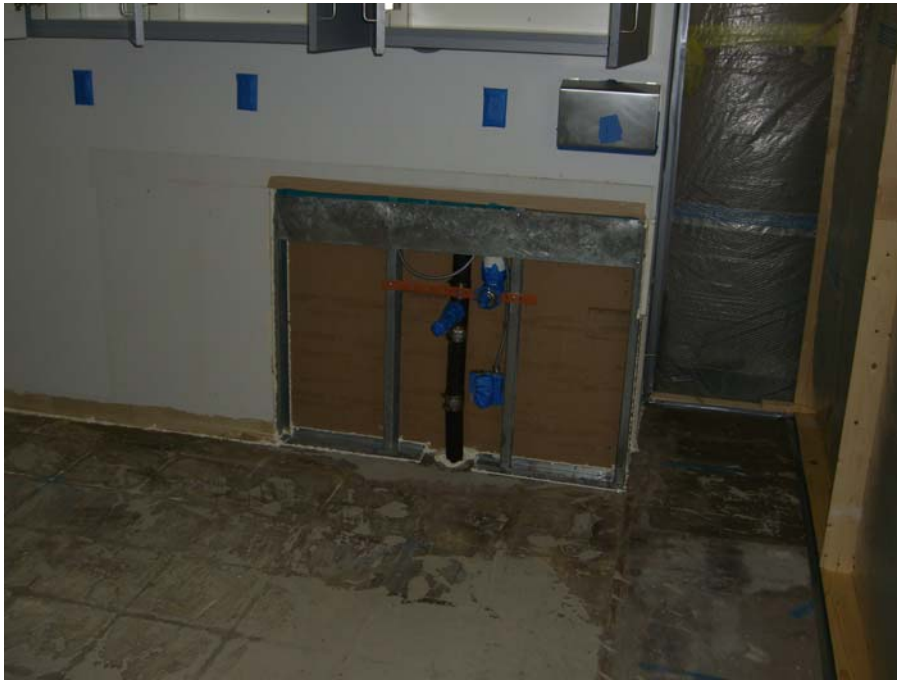
- 9) Image of interior of break room area 143 at time of assessment. Cabinets were removed and wallboard and concrete slab exposed during mitigative process.

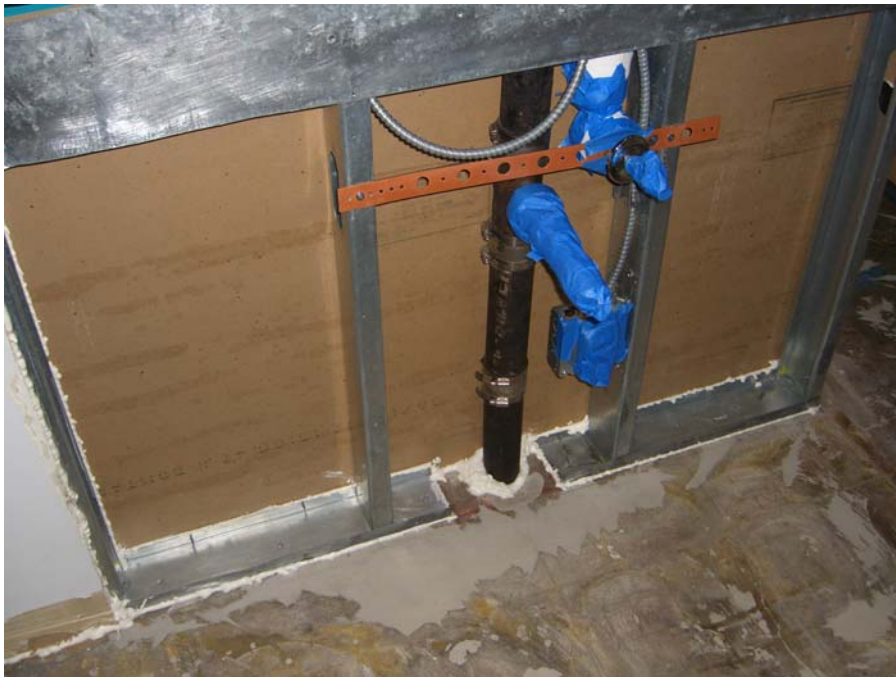
- 10) Additional image of interior wall plumbing within 143 break room area at time of assessment.

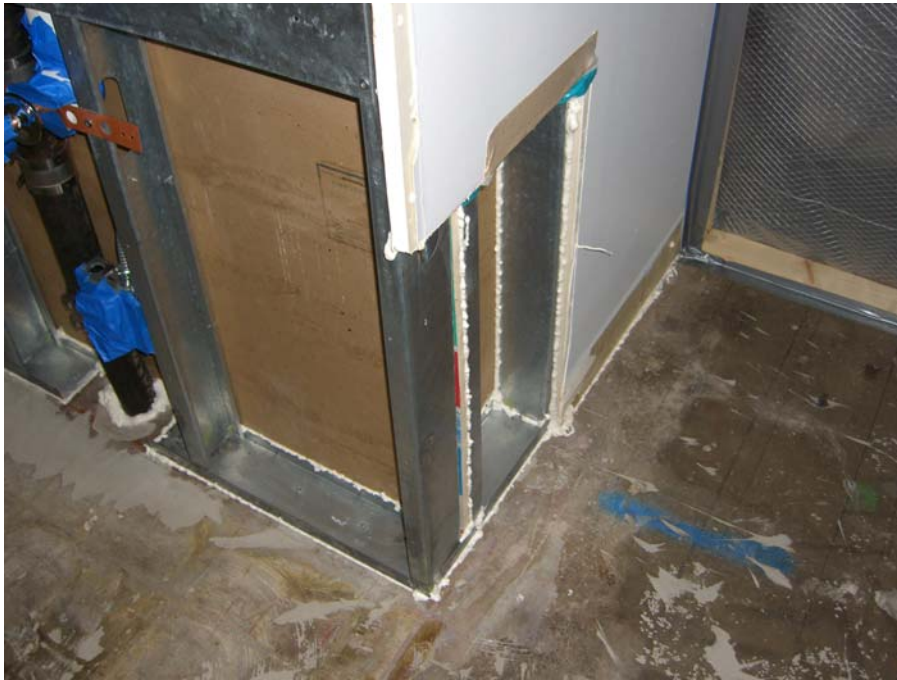
11) Corner view image of wallboard removal extent within break room 143 containment area at time of assessment.

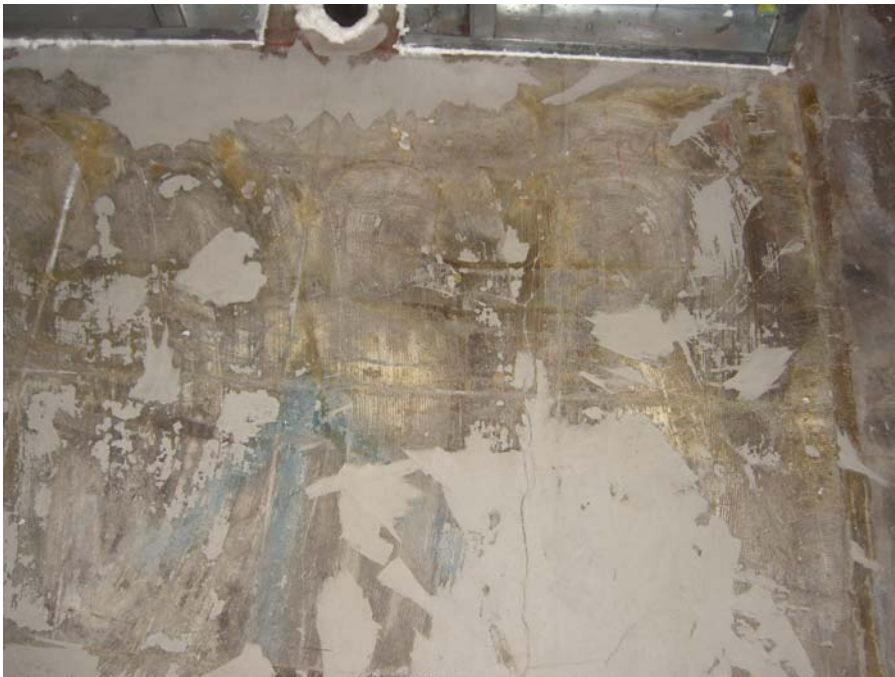
12) Image of concrete floor slab with residual glue and “suspect” dark staining present on surface. Sample S04 collected to assess for presence of elevated mold spores.

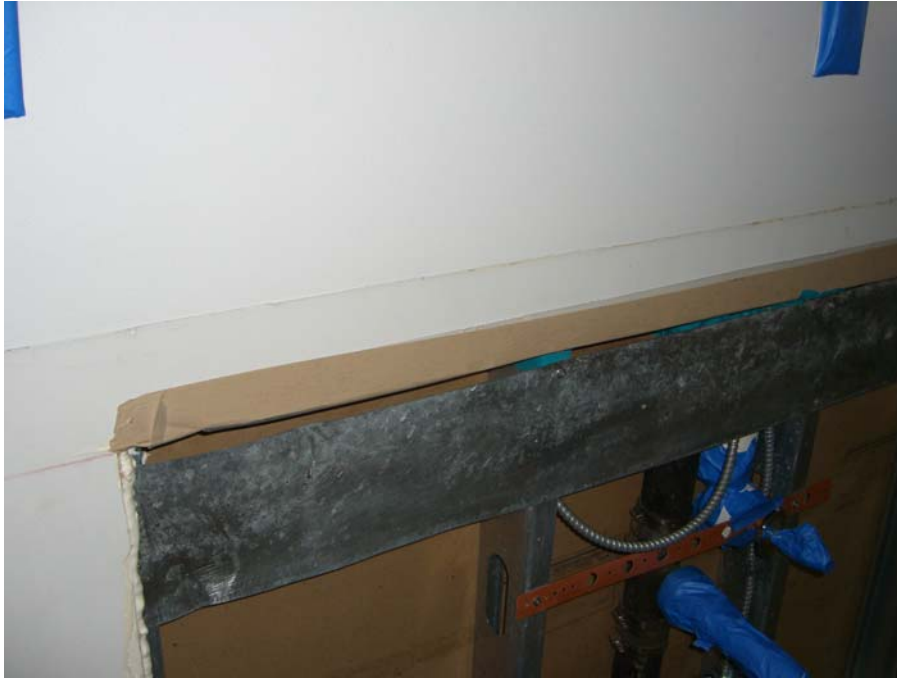
- 13) Image of metal flashing material remaining within wall cavity at prior cabinetry location. Such material surfaces were sampled by BioMax with sample S02 at time of assessment.

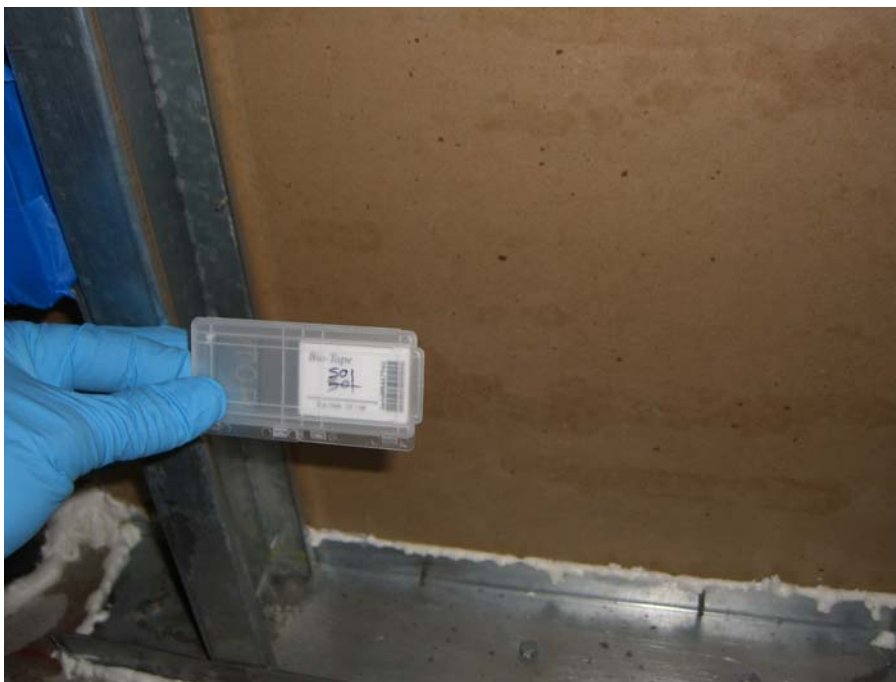
- 14) Image of surface sample S01 collected from wall cavity paper surface leading to adjacent bathroom area as accessed through cabinet wall space.

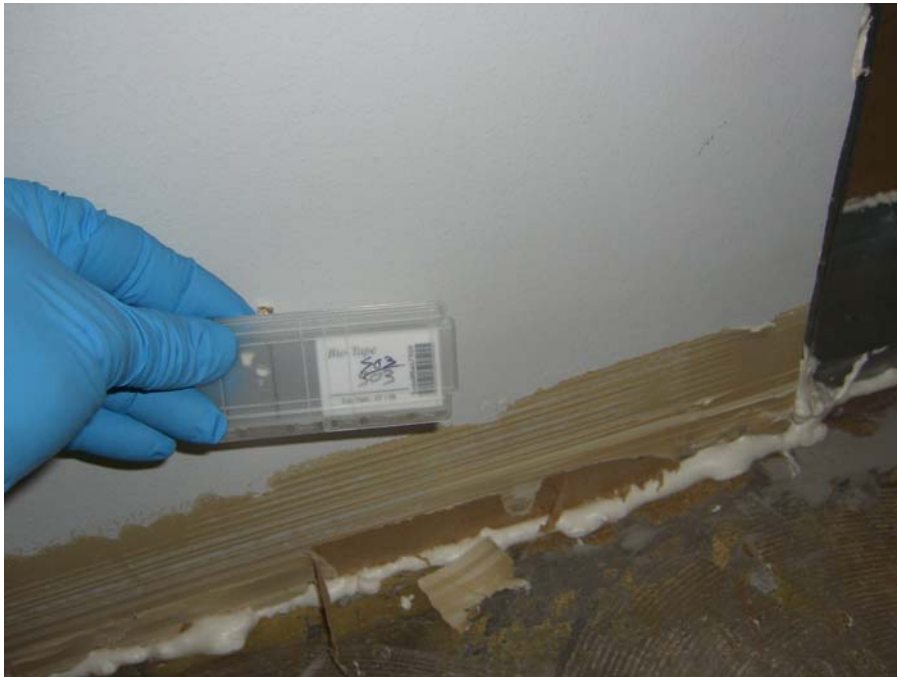
15) Image of surface sample S03 collected from exposed wall surface to left of cabinet material at baseboard level.

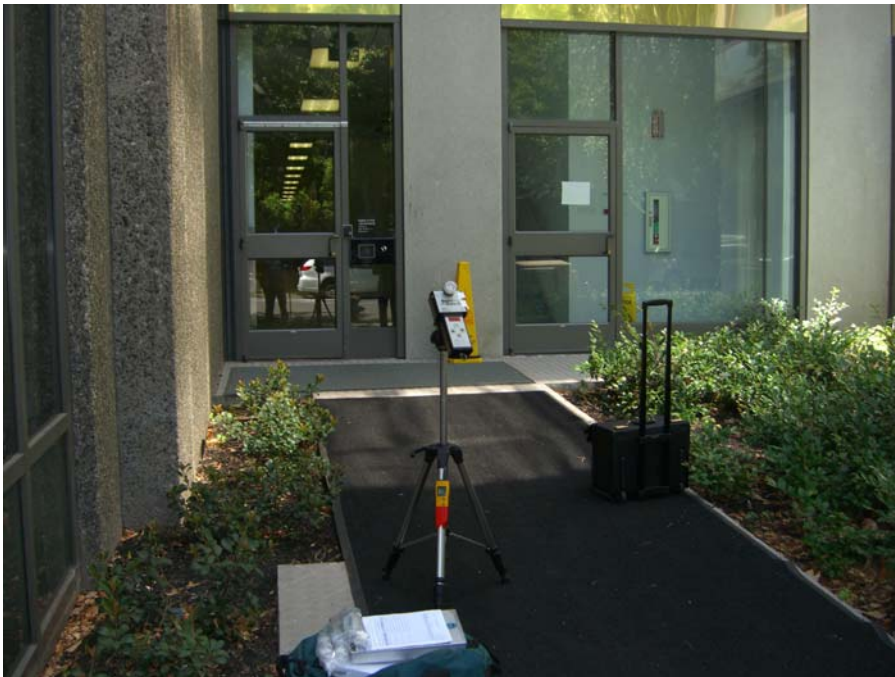
16) Ambient air sampling location to east side entrance of subject building following the collection of interior air samples.
